## Condition Report

*Gate Lodge*

Former Central Mental Hospital, Dundrum Road,  
Dundrum, Dublin 14

Date: September 2024

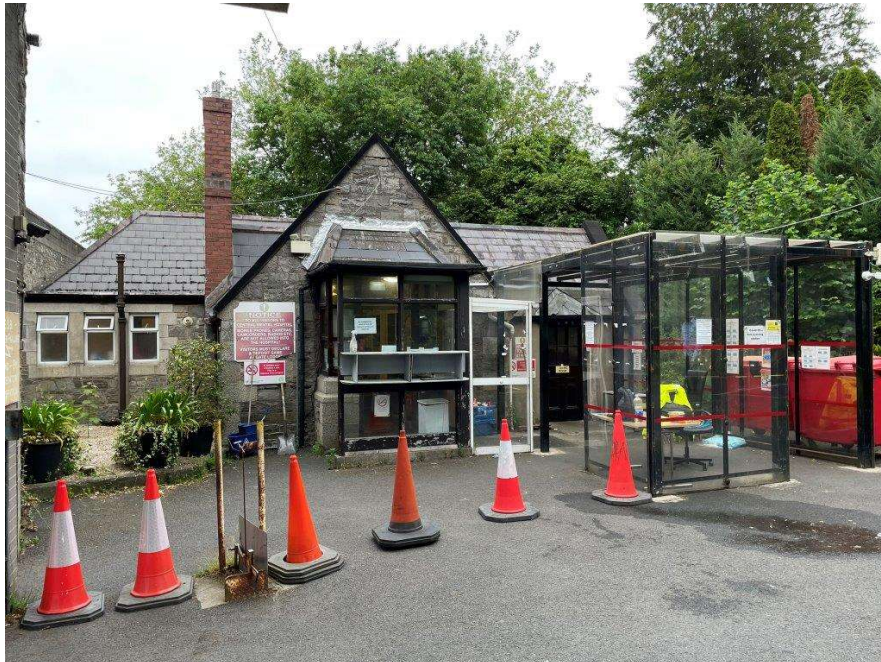
**Fig. 04:** Southern elevation with temporary structure screening on right hand side

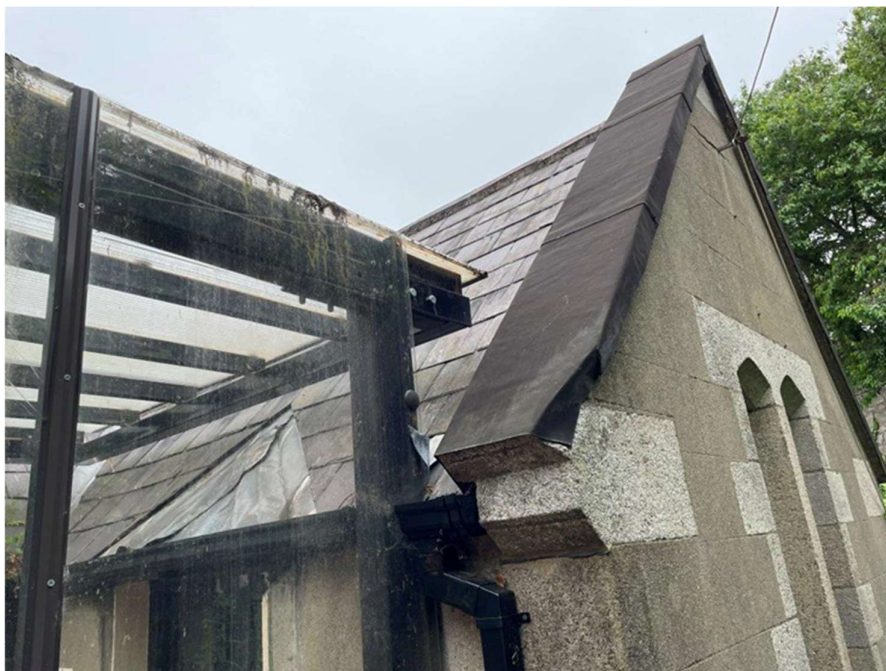
**Fig. 05:** Junction of temporary screening area and roof of Gate Lodge.

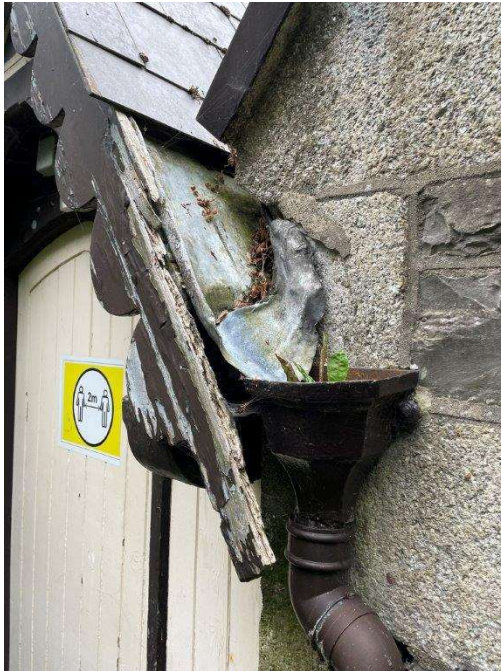
**Fig. 06:** Water ingress resulting in deterioration of decorative fascia to door at eastern elevation.

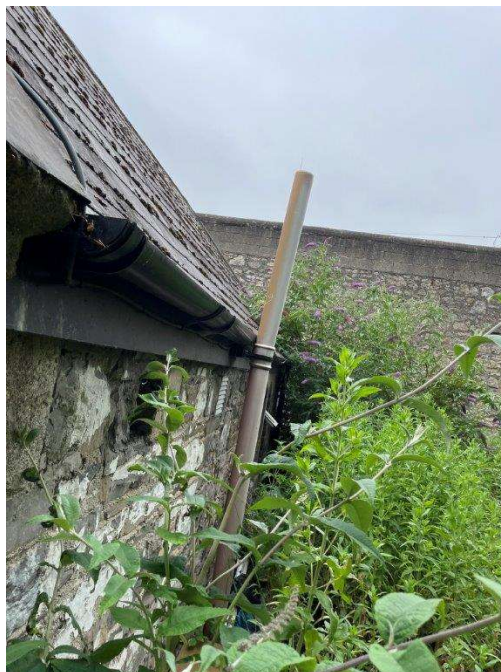
**Fig. 07:** Moss visible on roof slates at northern elevation.

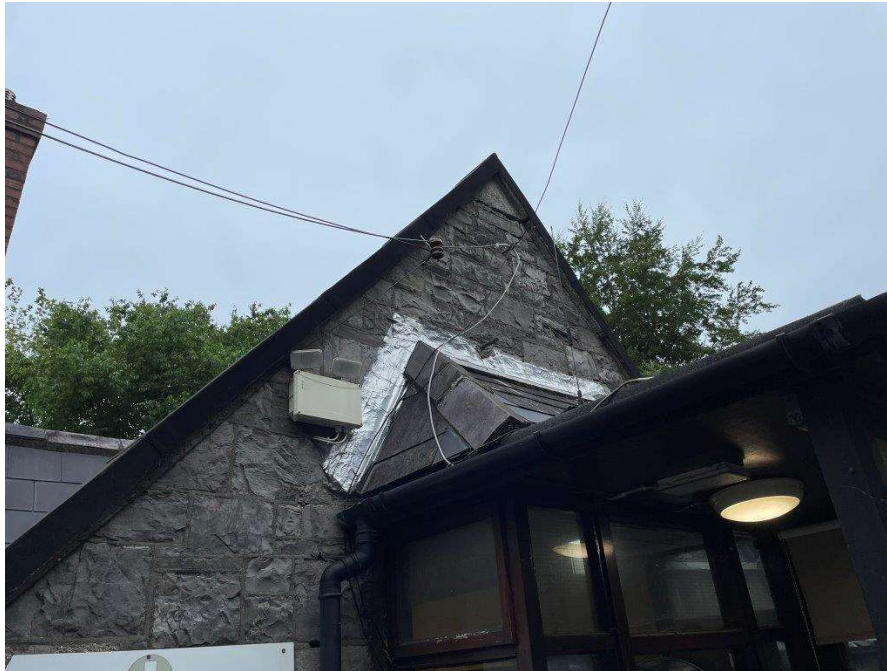
The roof consists of a slate finish with sections of bitumen to flat roofs and at barges. While it was not possible to inspect the roof structure, it likely consists of a cut timber construction. Flashings throughout the property were found to be of particularly poor condition with the following defects noted: Poor quality flashing used above porch on south façade. Bitumen covering to stone barges, suggesting issues with moisture penetration in the past. This is unsightly and a more satisfactory repair will be preferable. Debris noted in gutters / downpipes throughout increasing the risk of water ingress. Evidence of former repairs to roof noted at brick chimney with unsightly finish and flashing remaining. Section of roof to south façade appears to have been recently removed with a significant amount of lead flashing exposed to the elements.

**Fig. 08:** Flashing where lean-to roof at southern elevation meets stone wall.

This building has the potential to become an interesting gateway building to the Former CMH site should the above renovation works be carried out. It is recommended that the works to limit any further deterioration at the roof and flashings / valleys are carried out as a priority.

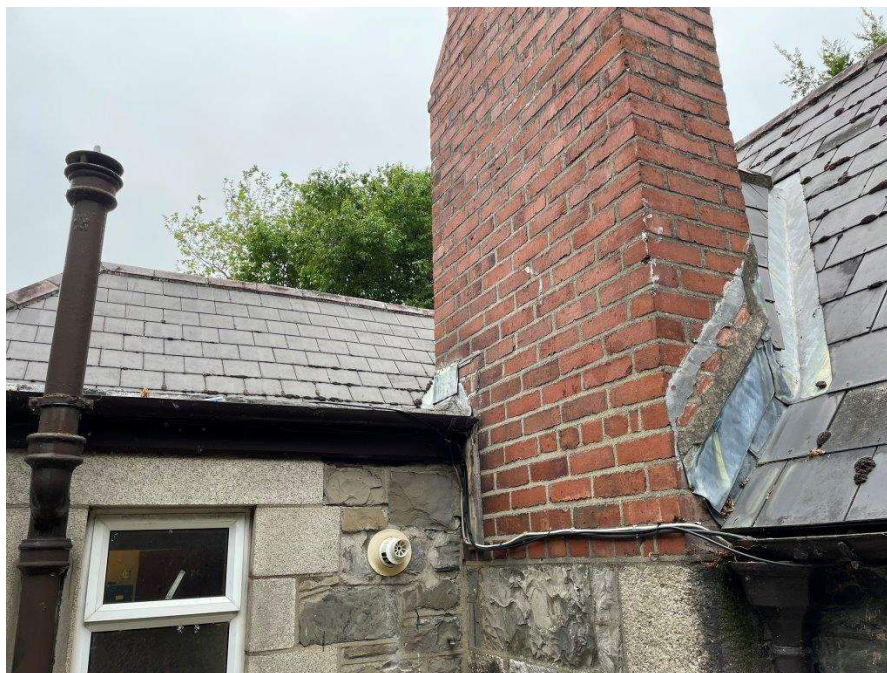
**Fig. 09:** Note previous line of flashing on brick chimney breast; gas balanced flue visible.

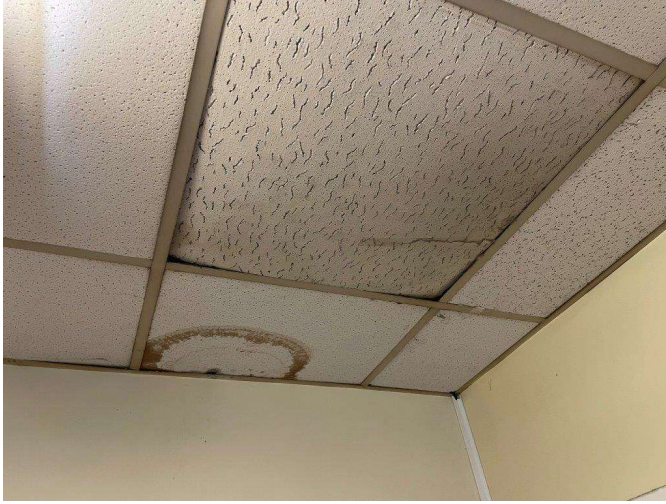
From an inspection at ground level, it appeared that the ridge line is free of any undulations which would suggest that the roof is in satisfactory structural condition, however an examination of the roof space would be required to confirm that there is no moisture ingress at the roof finish. Staining was noted on the ceiling tiles in the current reception indicating that a former leak occurred.

Ceilings throughout are generally formed in plasterboard with a gypsum skim finish with no decorative details noted. A suspended ceiling has been provided in the reception, which is in poor condition, showing evidence of water ingress, and will require to be replaced and the source of the moisture should be investigated.

**Fig. 10:** Deterioration/rot of suspended ceiling panels inside Gate Lodge due to water ingress.
